ENGINEER'S FIELD REPORT

Site: Boonsboro Reservoir

Project: Boonsboro Replacement Reservoir

Field Report Number: 02

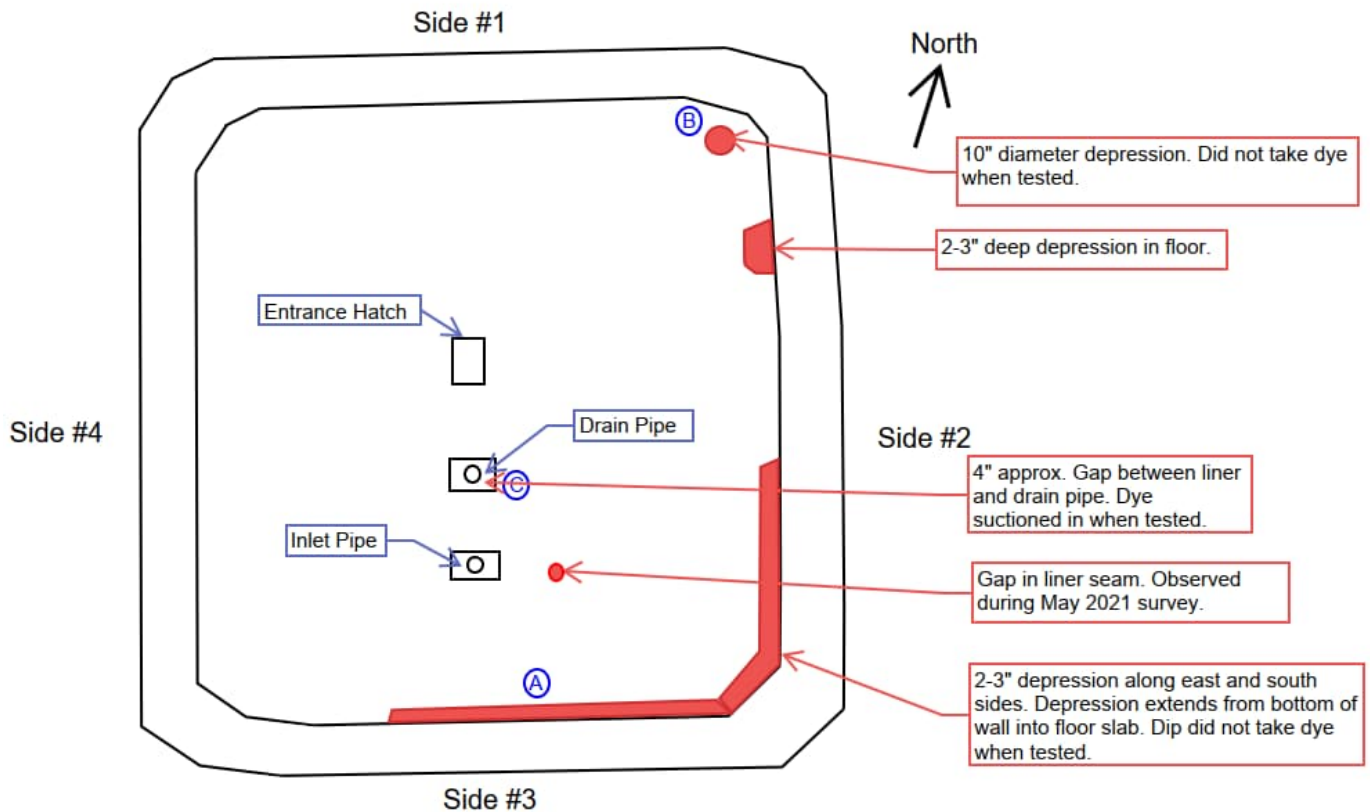
Figure 1: Dive Survey Inspection Notes

The videos from the second dive, files named MOV_009.mp4 and MOV_010.mp4, show many cracks in the concrete liner, mainly in the east and south side walls and floor area adjacent to these sides. No substantial dips or cavities were observed along the walls of the reservoir. The sunken areas identified by the divers were observed along the eastern and southern sides of the reservoir, where the walls meet the reservoir floor; and are approximately 2 to 3 inches deep. Additionally, an approximately 4- to 6-inch gap was observed at the connection of the drain pipe and the reservoir floor.

Figure 1 (next page) depicts the location of the observations and dye tests.

Commander Eaves performed three dye tests at the locations shown below. The first test was performed at the dip along the southern floor edge and the second test was performed at the dip observed on the northeast corner of the reservoir floor. Dye was suctioned or taken at neither of these locations. The third test was performed at the gap

between the drain pipe and the reservoir floor, here the dye was suctioned into the hole. This last test proves that water loss is occurring at this location.

As a temporary solution, we recommend the leak by the drain pipe and the gap in the seam adjacent to the inlet pipe be covered by tightly packed sandbags, in order to lessen the current water loss. For a more permanent solution, the reservoir would have to be drained and the liner patched in accordance with the manufacturer's instructions. The patching instructions provided by the manufacturer (Burke Environmental Products) have been attached to this report.
