# TOWN OF BOONSBORO

The Lead and Copper Rule Revision (LCRR), effective December 16, 2021, requires all community and non-transient non-community water systems to develop a service line inventory to identify the material(s) of service lines connected to the public water distribution system. The Town of Boonsboro would greatly appreciate your help in identifying where the lead water service pipes are located in our town, so we are able to determine a good plan for replacing all of the lead water service lines. Water service lines are the pipes along your property that run from the Town's water main to the water meter to your home (see diagram below). Common water service line materials found in homes include copper, lead, galvanized steel, and plastic. Your input is essential in helping us update our records. A survey form is located on the enclosed card. Please read through the information and instructions first as it will show how to determine the material of the water service pipe that is entering your building/home. To identify the material of your water service line, please follow the step-by-step instructions below. Alternatively, you can contact a licensed plumber to identif

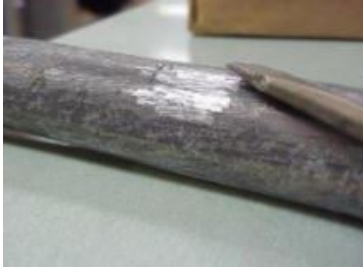
Your Service Line is Lead if:  
**Scratch Test:** Area is shiny & silver.  
**Magnet Test:** Does not stick.

Some additional information and example photos that may help you identify your pipe material is below: Lead pipes may be thicker than the other pipes in your house. Lead pipes will have characteristic bulbed “wiped” joints where they meet with other materials. Copper pipes may corrode to a mint green color like the Statue of Liberty. Galvanized pipes are usually threaded at the connections- they screw into their fittings. Galvanized pipes are usually straight- they do not curve like lead pipes.

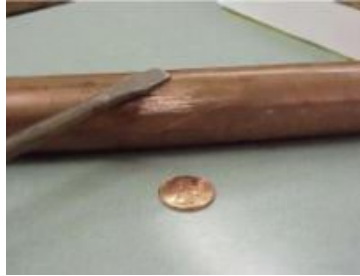
Your Service Line is Copper if:  
**Scratch Test:** Area is copper in color like a penny.  
**Magnet Test:** Does not stick.

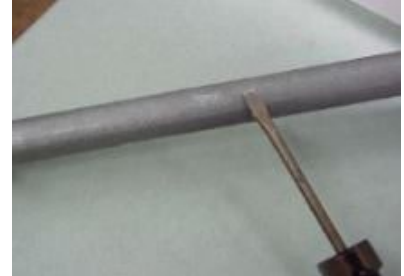
Your Service Line is Galvanized if:  
**Scratch Test:** Area remains dull gray.  
**Magnet Test:** Magnet sticks
